UNDERWATER BRIDGE INSPECTION REPORT

STRUCTURE NO. 24514

SHELL ROCK CHANNEL

DISTRICT 6 - FREEBORN COUNTY, CITY OF ALBERT LEA

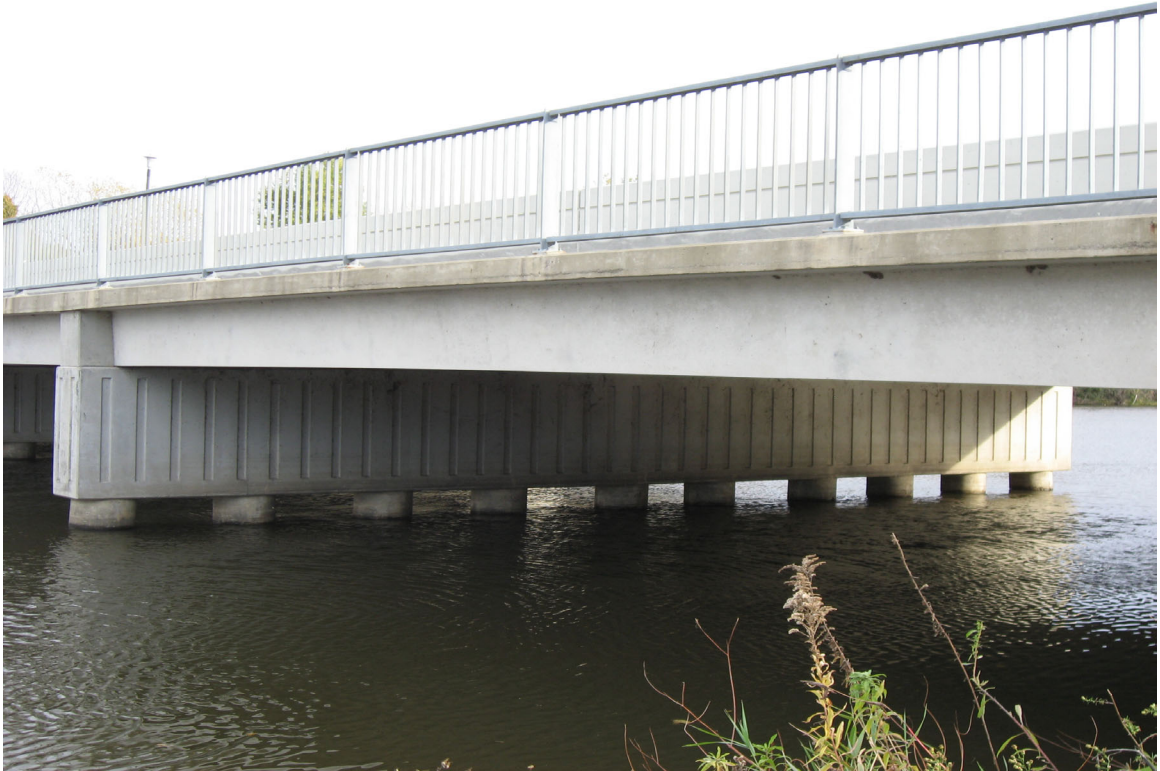
Photograph 1. View of Pier 1, Looking Southeast.

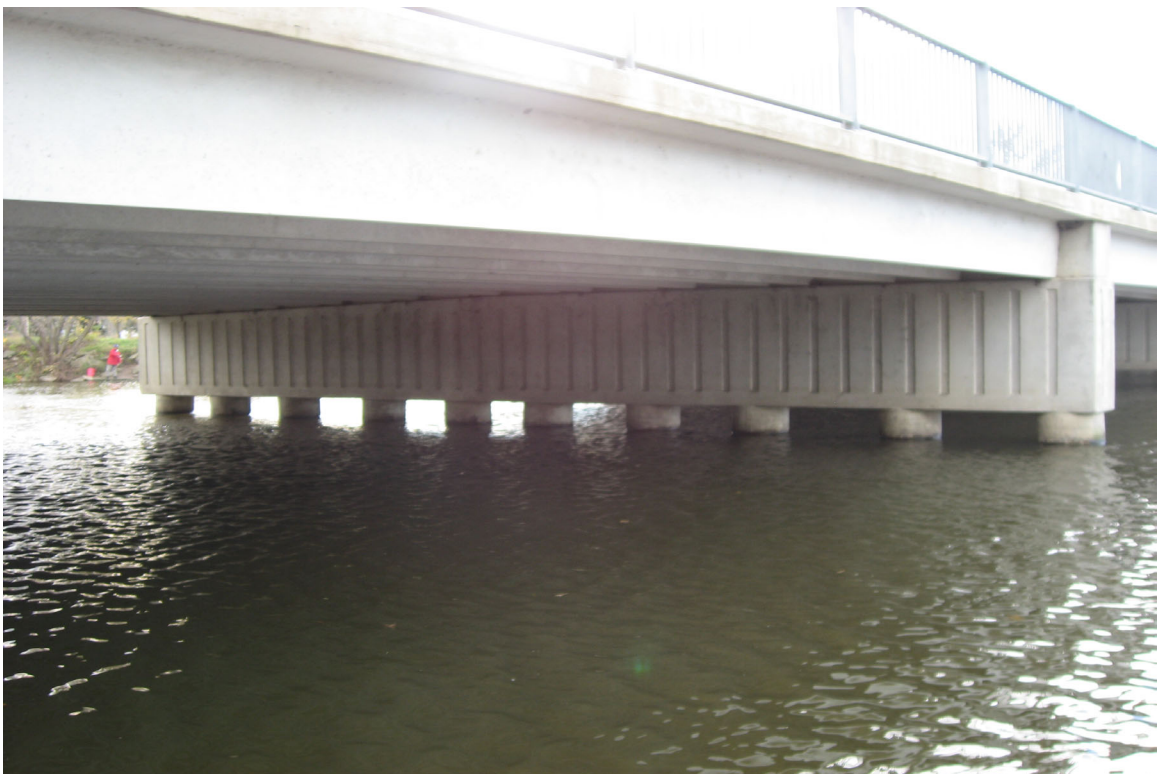
Photograph 2. View of Pier 2, Looking Southwest.

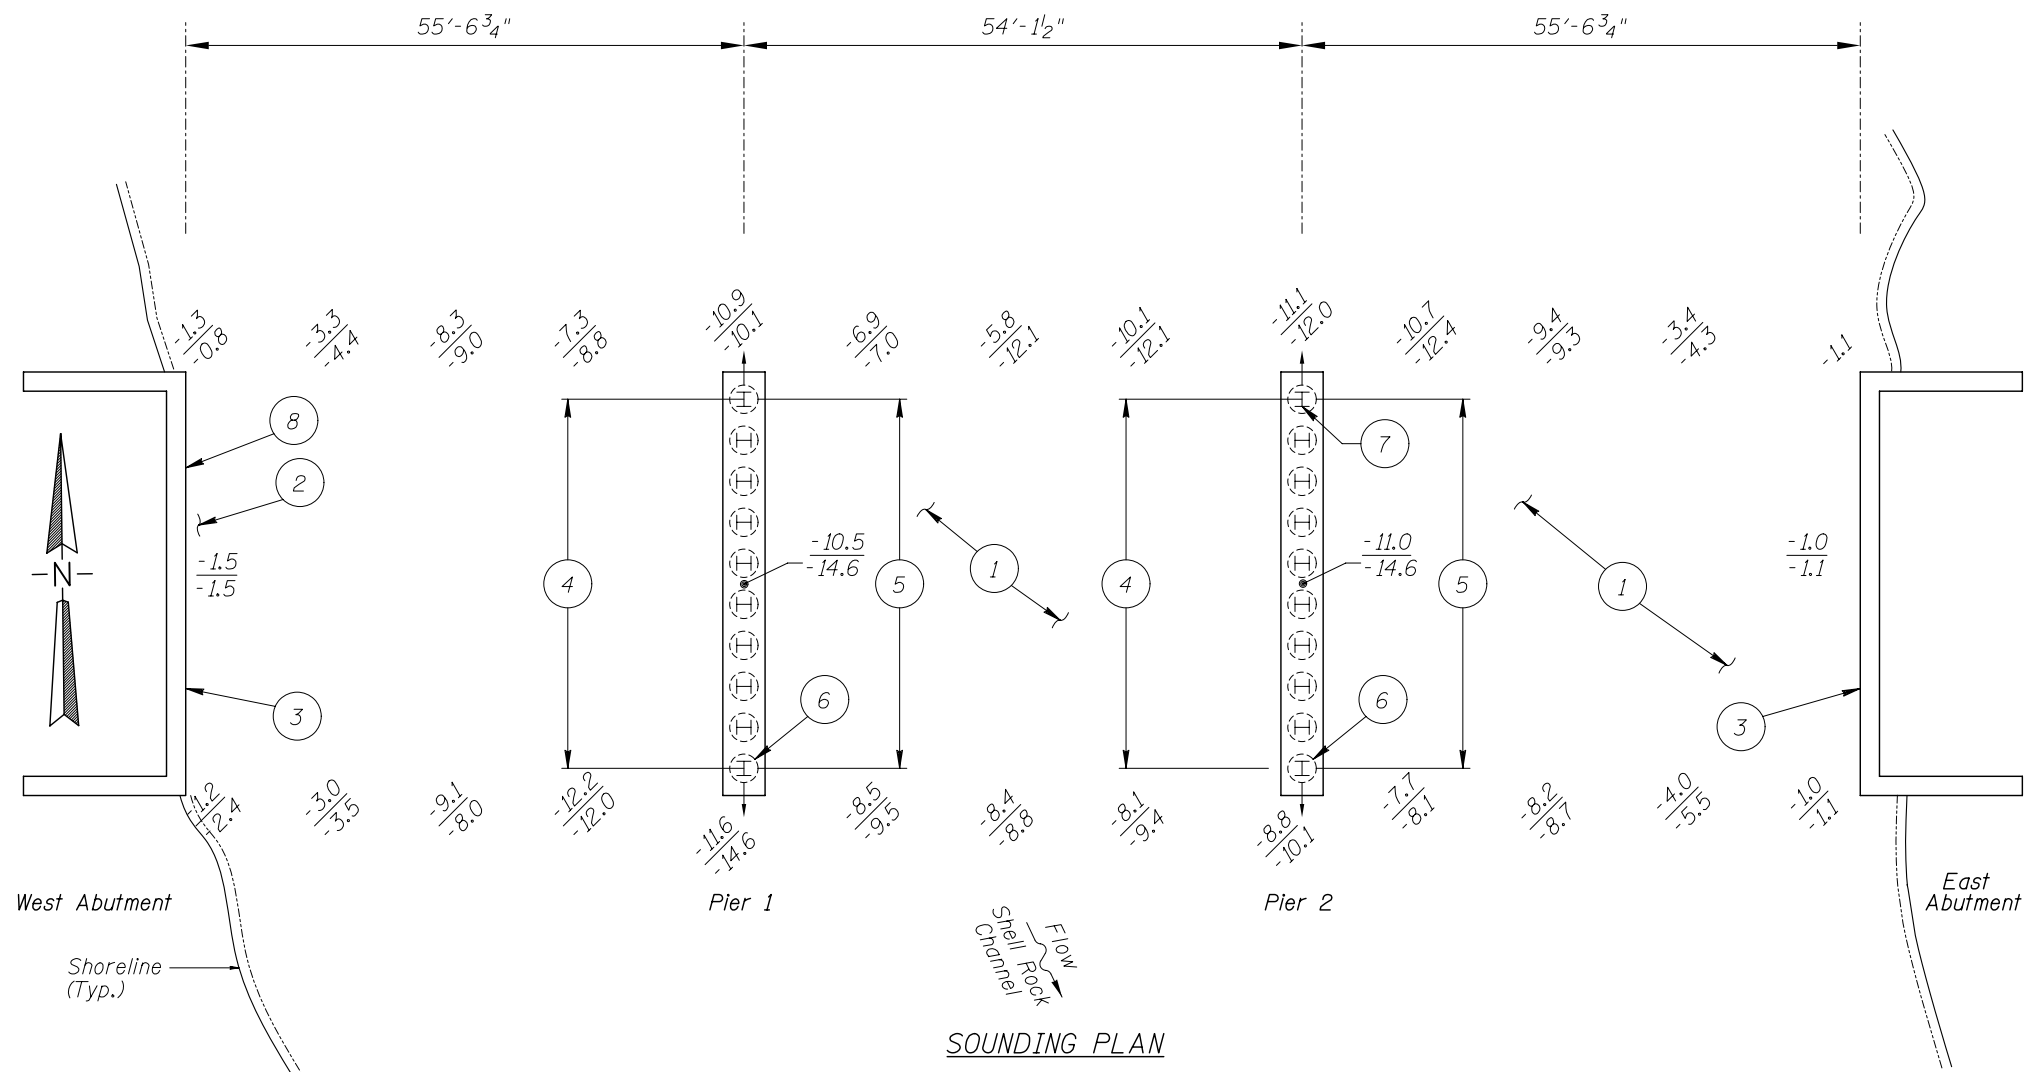
INSPECTION AND SOUNDING PLAN

1. The channel bottom consisted of silty sand with up to 1 foot of probe rod penetration.
2. The channel bottom consisted of sandy gravel, cobbles and rocks up to 2 feet in diameter with up to 8 inches of probe rod penetration.

3. Overall, the concrete abutments were in smooth and sound condition with no structurally significant defects observed.
4. The steel H-piles exhibited 100 percent coating failure with moderate surface corrosion with up to 1-inch-diameter rust nodules and 1/32-inch-deep pitting over approximately 50 percent of the surface area. Majority of nodules were scattered and 1/4 inch diameter in size.

5. The concrete encasements exhibited map cracking and widespread areas of section loss with up to 6 inches of penetration from the waterline to the bottom of the encasement. Frequent areas of exposed reinforcing were also noted.

6. Timber and steel formwork was still in place.
7. A welded splice of steel H-pile was observed 7.5 feet below the waterline and was in good condition.

8. An area of section loss, 2 feet high by 2 feet wide, was observed above the waterline with up to 1 inch of penetration.
